## **Roof Structure Condition Assessment - Final Study Report**

**Neon Museum Lobby Building  
Las Vegas Nevada**

**Melvyn Green & Associates, Inc.  
Torrance, CA 90503**

**AQYER Consultants**

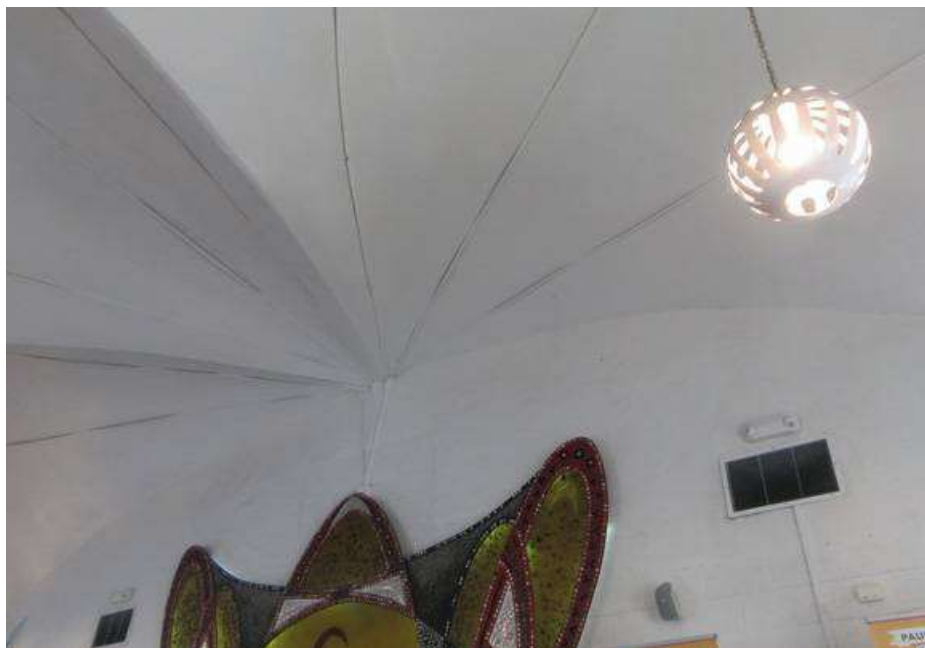
Photo 3 - Interior wiring today. In many areas the wires have lost their adhesion to the ceiling plaster.

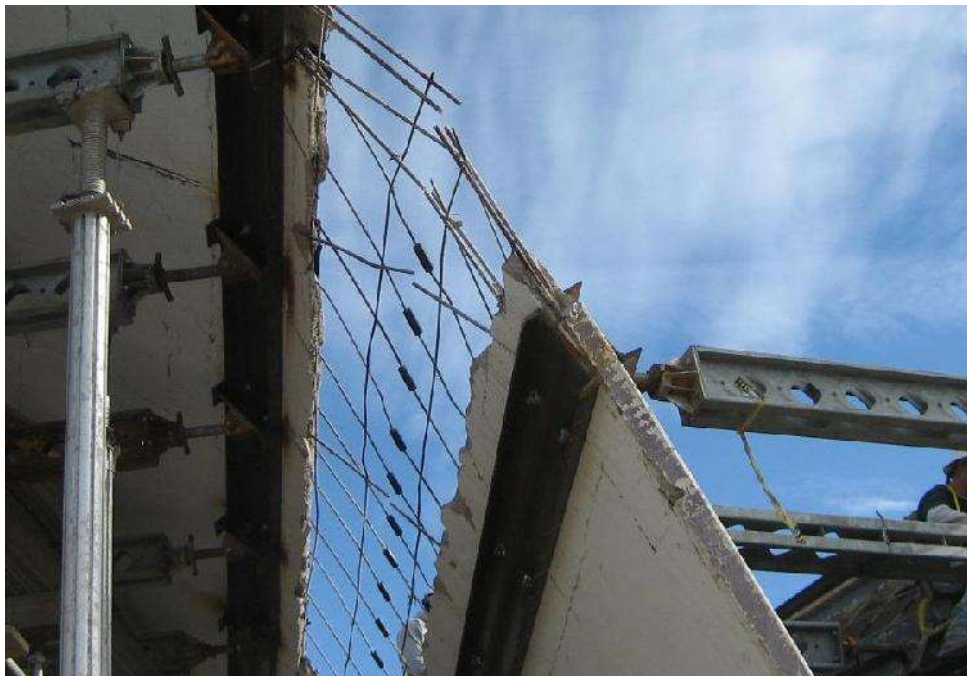
Photo 5 - Example of the joint between the several concrete sections. Mechanical splices can be seen. In some cases, because of the reinforcing steel was too close to the surface, welding was required.

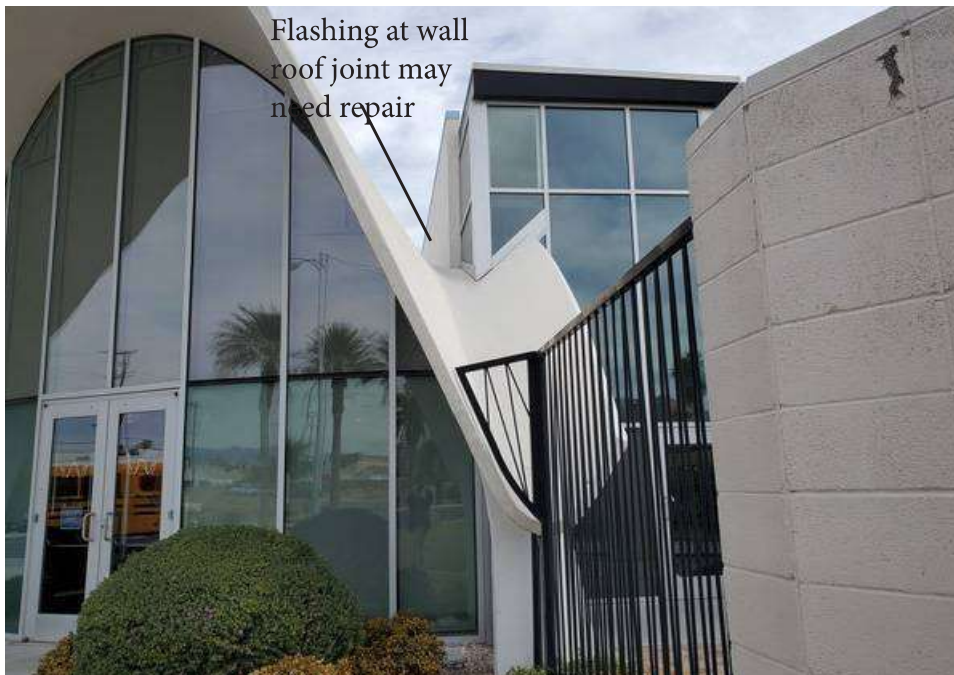
Along the interior side near the top of the back wall (southwest corner), there might be a small leak or it might be salts coming to the surface from the CMU and mortar. this is not an issue but might be unsightly if it continues. But it could be very minor leakage at the flashing between the roof and wall.

Photo 6 - The shell and vertical wall intersection needs to be flashed to properly direct the water. Possible water intrusion may occur along the roof in the areas shown and at the window. This needs to be inspected and repaired.

Roof/Wall flashing – There was some evidence of possible leakage at the back wall near the south doors. There might be some damage to the flashing and the joint between the roof and wall. It is recommended that a professional roofing contractor be retained to inspect and repair the flashing as needed.

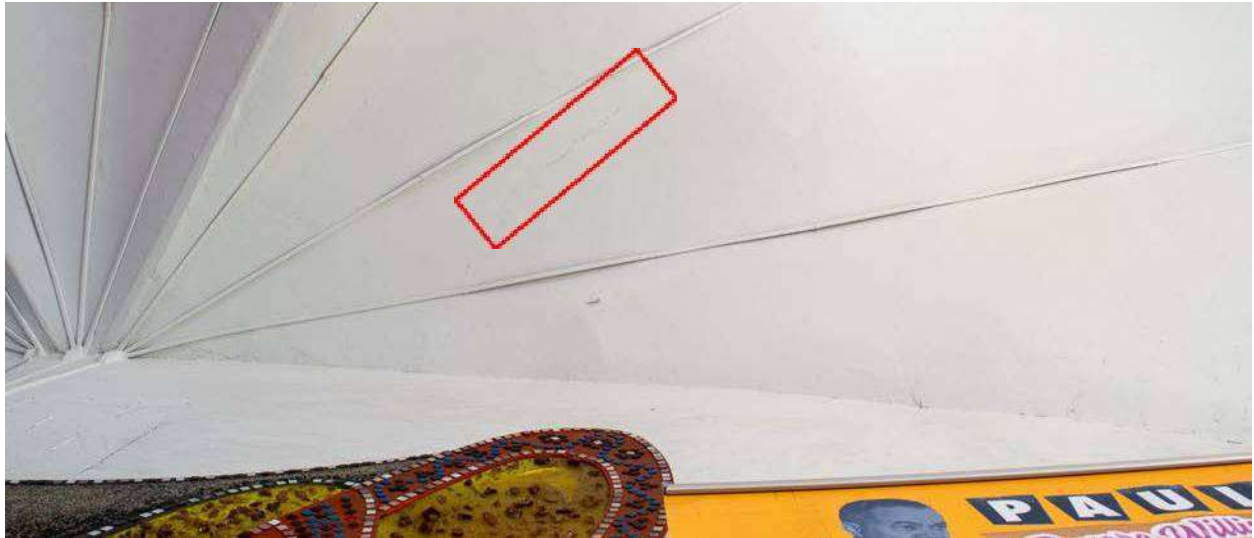
Visitor Center Soffit: Visible crack, approximately 18" in overall length, close to the back wall

With better access, such as a scaffold or aerial lift, it would have been possible to inspect the crack at the soffit to see if it was related to a particular piece of reinforcement, low cover, and / or high congestion. In an area of cracking observed on the exterior soffit (south east corner, as marked on drawing R-103) it was possible to confirm that individual cracks were coincident with

individual reinforcement bars. Whether the cracks were caused by expansive corrosion of the bars or by thermal loading, the open cracks are susceptible to moisture infiltration which can exacerbate corrosion and lead to further deterioration. Tap testing was used across the area, and confirmed that the visible cracks extend deeper than the surface finishes, though none of the concrete tested appeared to be loose and in immediate danger of falling.

While GPR can be used for determining concrete thickness, the 3D point cloud data is considered more reliable, and was used to create a section through the cracked region at the visitor center interior; the section indicates that the concrete is as little as 3¼ to 3½ " thick at the crack location.

Existing ceiling crack – The goal here is to patch any areas of possible leakage before the water might enter the roof concrete and rust the steel and leaks through the ceiling. The preferred option would be to repair this from the roof. This would require removal of a portion of the existing covering, filling the crack with a flow-able material, the patching the roof. Repairing for the underside of the roof might result in greater damage and interruption to use of the lobby.

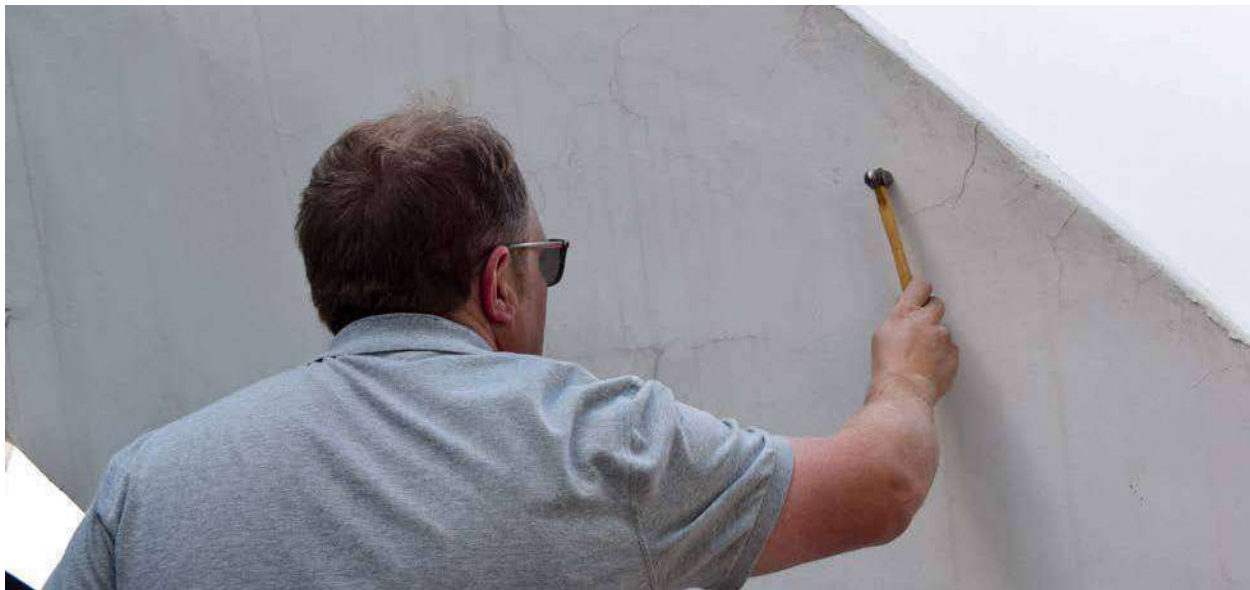
A small pin hammer was used to sound the exterior soffit of the roof overhang at the south east corner of the building where visible cracks were identified at the surface.

Tap Testing: Cracked surface at south east corner of roof overhang

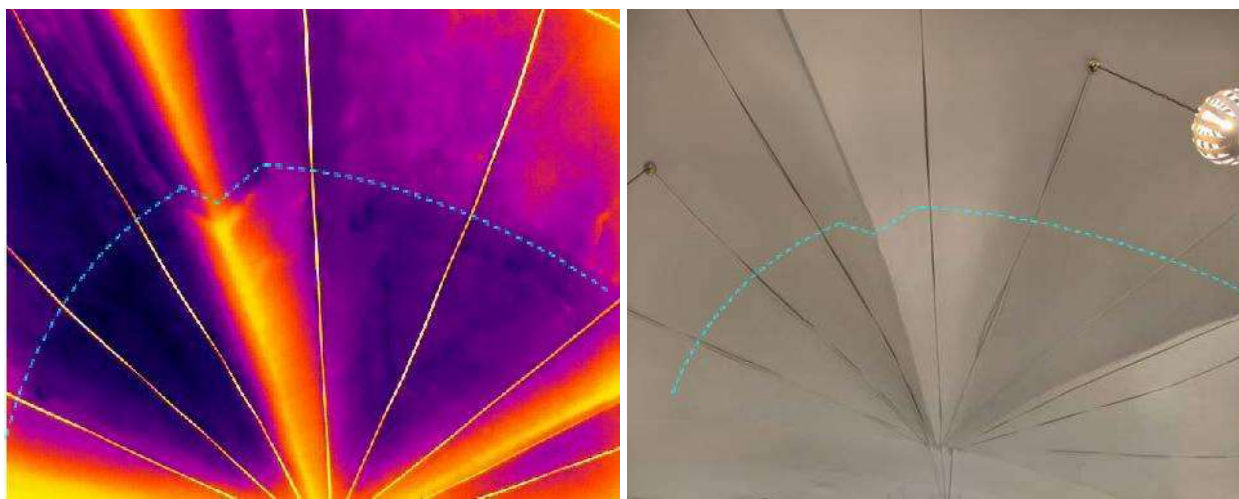
The most significant thermal response identified shows us where the structure was cut and later reconstructed. As highlighted in the interior soffit images below.

Thermal Image: A clear separation can be seen between sections of the reconstructed roof

No evidence of imminent spalls (separation of concrete) or other causes for immediate concern were identified within any of the thermal images collected.

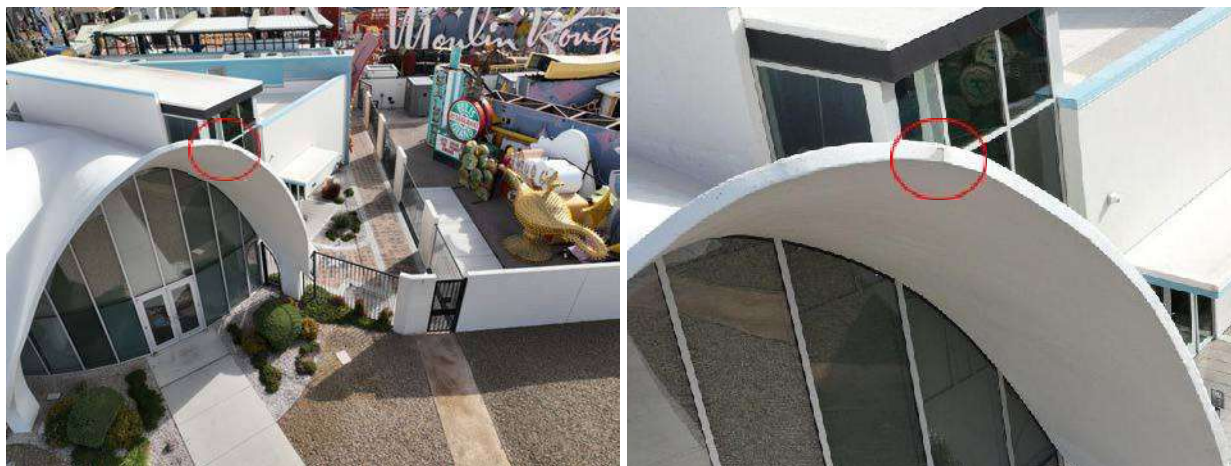
Aerial imaging of the roof structure allowed for us to get a close view of the entire roof surface. From this, a small number of areas exhibiting penetrative damage to the roof membrane / finishes were identified. Four locations are marked on the reflected ceiling plan shown in drawing R-103, and two are shown on the Roof plan shown in drawing R-104. Each of these defects is located at or close to the edge of the roof - extremities most exposed to weathering. Consideration should be given to repairing those areas before problems of moisture infiltration develop and the extents of the defects increase.

Membrane Damage: Image of defective membrane at north west roof overhang

Although the roof is not perfectly smooth, with many undulations and varying degrees of roughness, the membrane appears to be largely intact, with the exception of those 6 areas highlighted in drawings R-103 and R-104.

Replacement of the roof covering will be needed in the not to distant future. This should be planned for and the product selected. Research may be needed to find what product was originally used.

In the meantime the roof should be inspected and repaired as necessary.

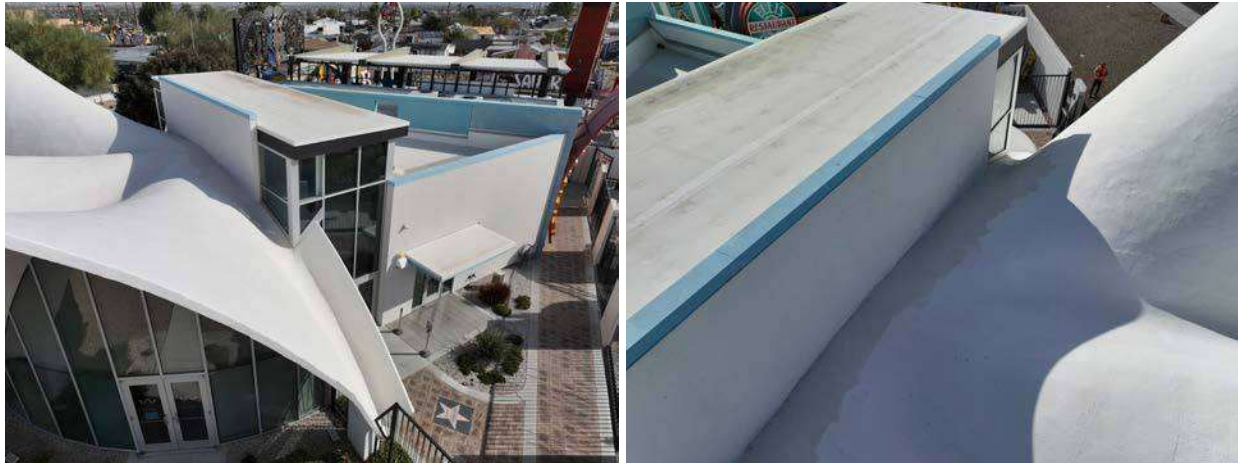
Given its proximity to the visible interior soffit crack, special consideration was paid to the block wall which forms the back of the visitor center and extends up above the main roof line. An album of images is available to view, [here](#), where the area can be further inspected. Given the susceptibility of CMU block walls to water infiltration, its interaction with the roof, and its interaction with the curtain wall, there should be a priority requirement to ensure proper

Aerial Images: Intersection between the historic roof structure and the CMU block wall

maintenance. A review of the flashing detail is and regular maintenance is recommended to curtail moisture infiltration that could pass down through the block wall and accumulate between the roof structure and the membrane.
