## **Roof Structure Condition Assessment - Final Study Report**

**Neon Museum Lobby Building  
Las Vegas Nevada**

**Melvyn Green & Associates, Inc.  
Torrance, CA 90503**

**AQYER Consultants**

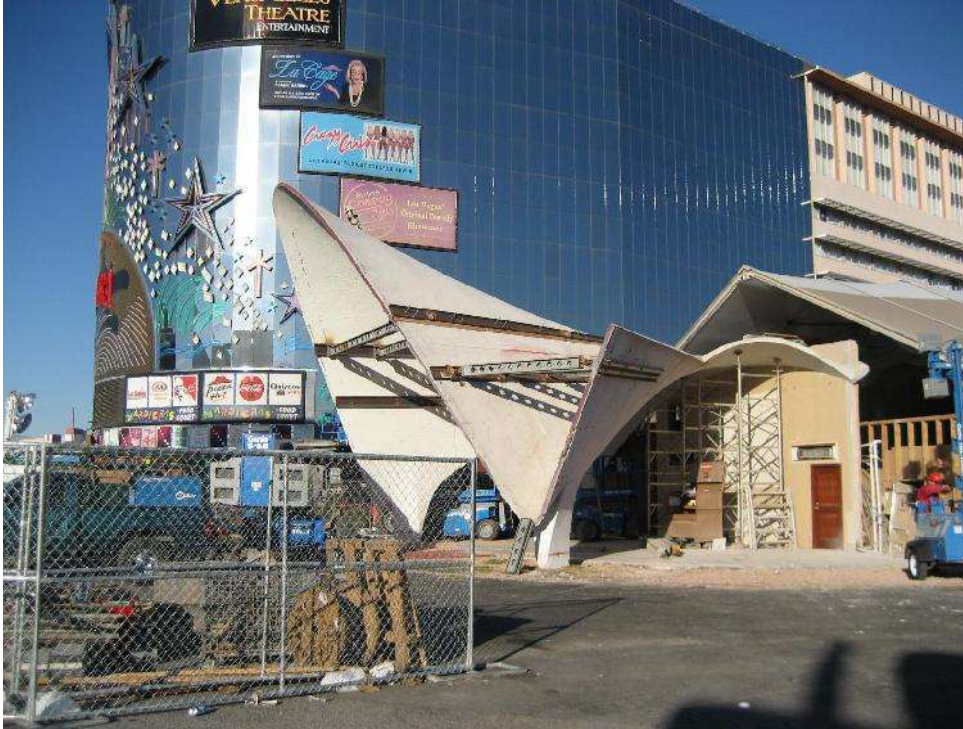
Photo 4 - This photo shows how the various sections of the shell were cut. The sections were then stored for reassembly.

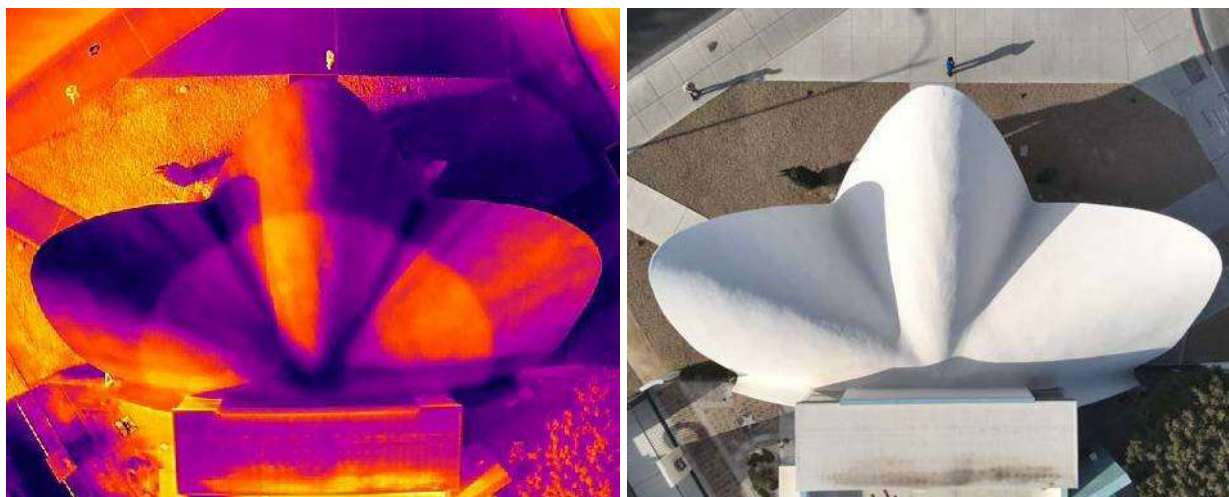
Thermal Overview: Showing broad variations in temperature associated with shadows, and a contrast between the (warmer) semi-circular interior space and the (cooler) cantilevered roof sections

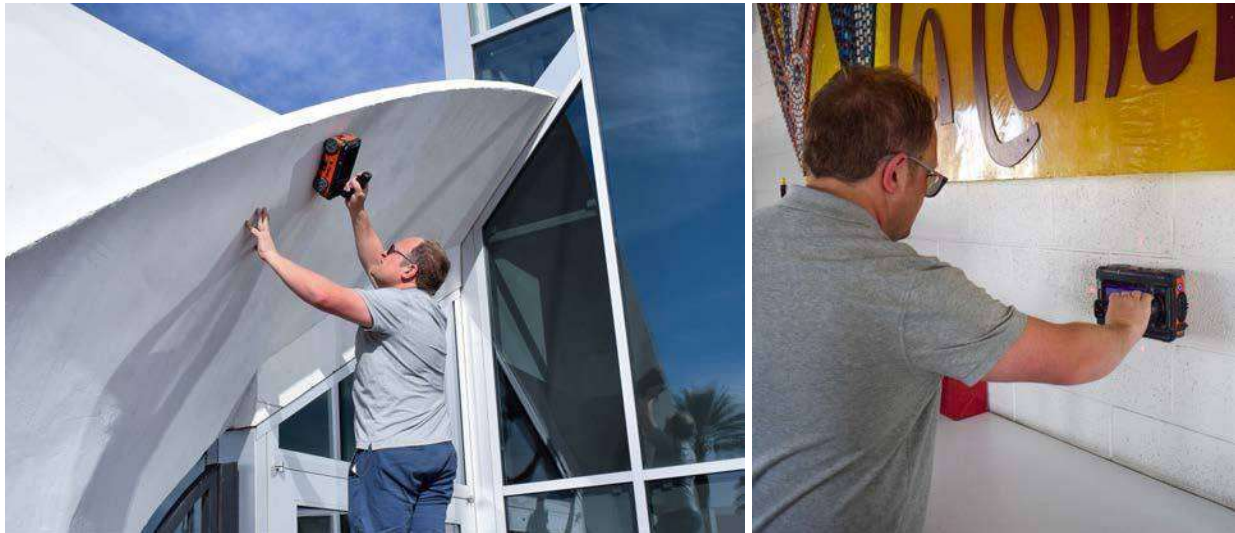
GPR Data Collection: Identifying the reinforcement arrangement within the concrete roof (left) and demonstrating the identification of vertical reinforcement and cell grouting in the CMU wall (right)

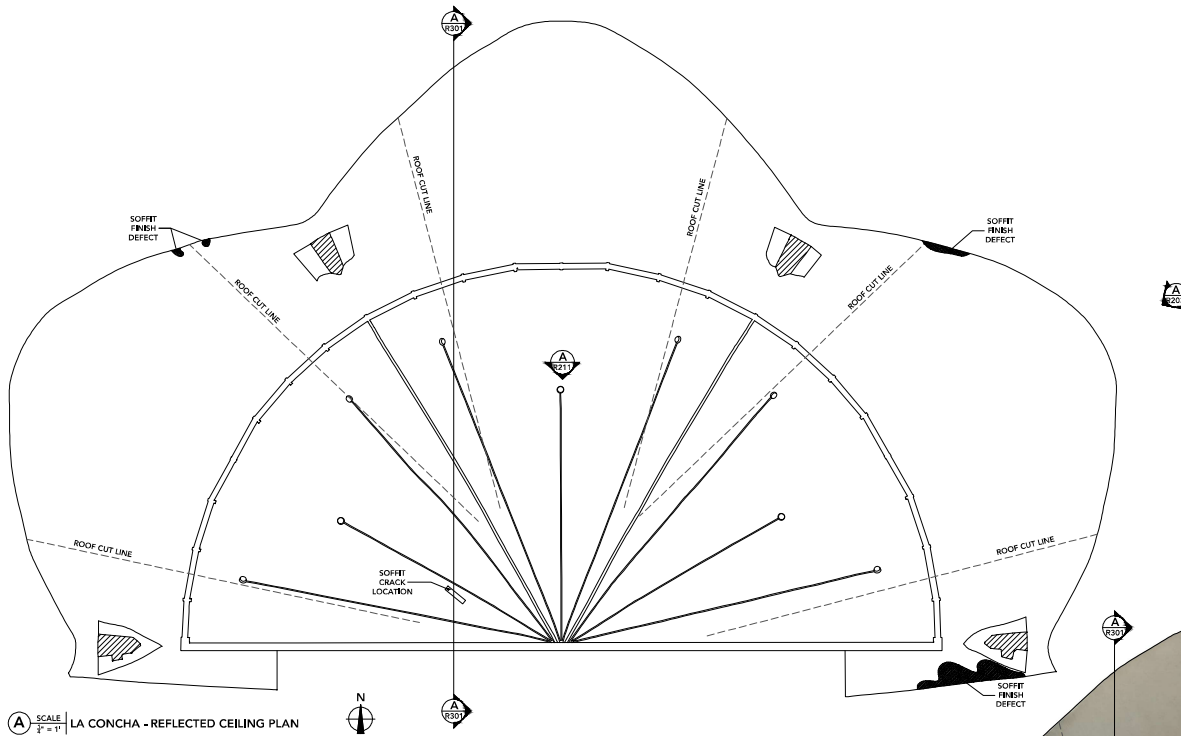
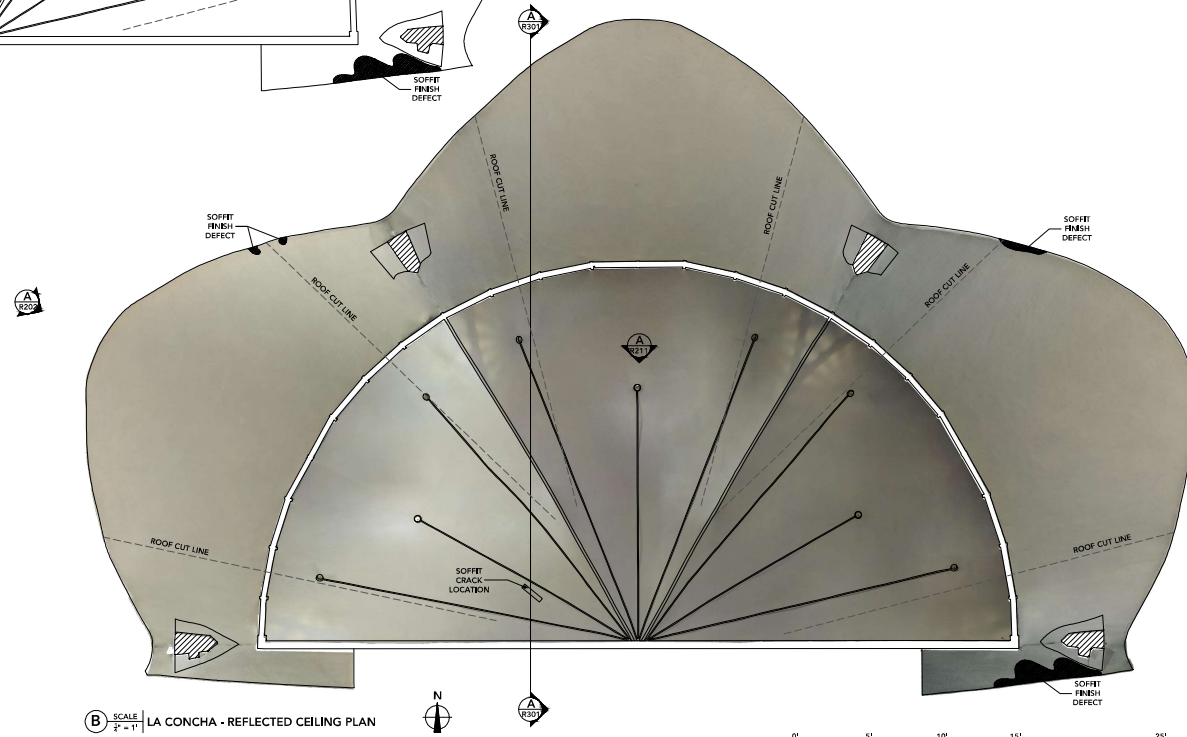
**R-103**

The scope of work was focused on the roof of the visitor center building, specifically the area of visible damage above the check in desk, as highlighted in the image below and drawing R-103.

With better access, such as a scaffold or aerial lift, it would have been possible to inspect the crack at the soffit to see if it was related to a particular piece of reinforcement, low cover, and / or high congestion. In an area of cracking observed on the exterior soffit (south east corner, as marked on drawing R-103) it was possible to confirm that individual cracks were coincident with

individual reinforcement bars. Whether the cracks were caused by expansive corrosion of the bars or by thermal loading, the open cracks are susceptible to moisture infiltration which can exacerbate corrosion and lead to further deterioration. Tap testing was used across the area, and confirmed that the visible cracks extend deeper than the surface finishes, though none of the concrete tested appeared to be loose and in immediate danger of falling.

While GPR can be used for determining concrete thickness, the 3D point cloud data is considered more reliable, and was used to create a section through the cracked region at the visitor center interior; the section indicates that the concrete is as little as 3¼ to 3½ " thick at the crack location.
